VILLAGE OF BEAVER SITE ASSESSMENT PROJECT REPORT

BEAVER, ALASKA

January 4, 2002

Prepared for the Alaska Department of Environmental Conservation
by

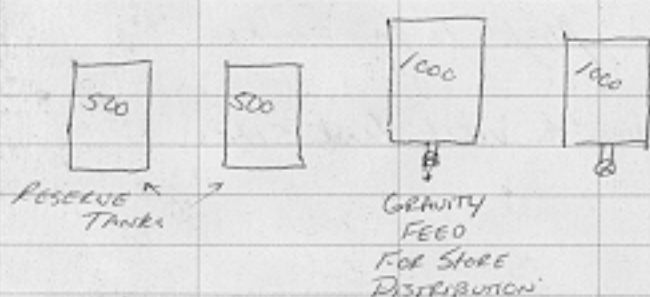
* NO CONTAINMENT AREA

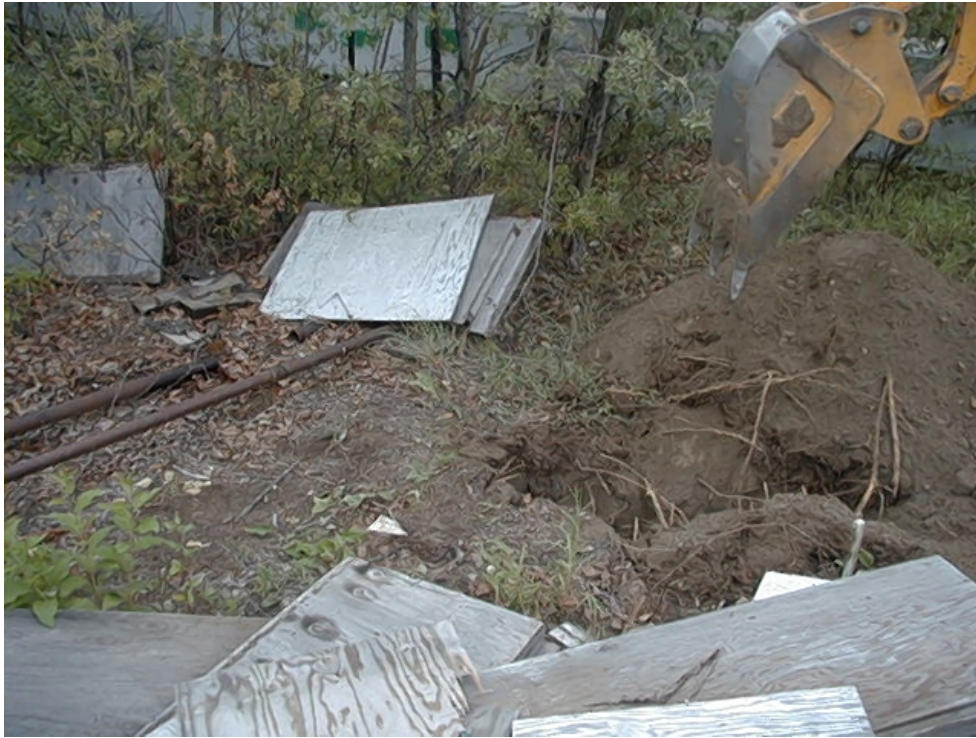
Photo # 103: Soil sample location on south end of School Tank Farm.

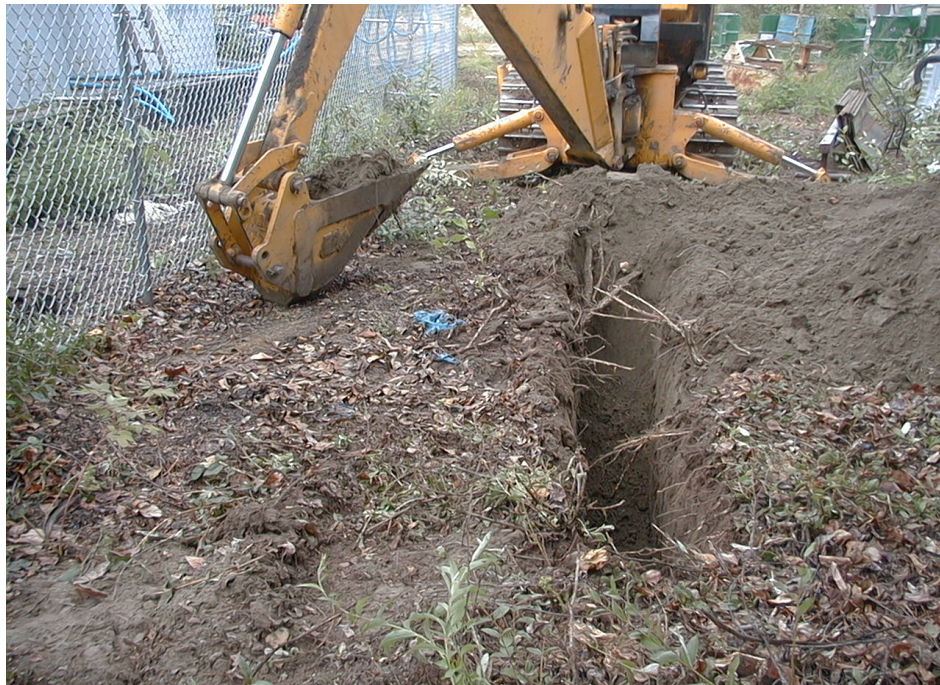
Photo # 91: Soil sample area on north end of School Tank Farm

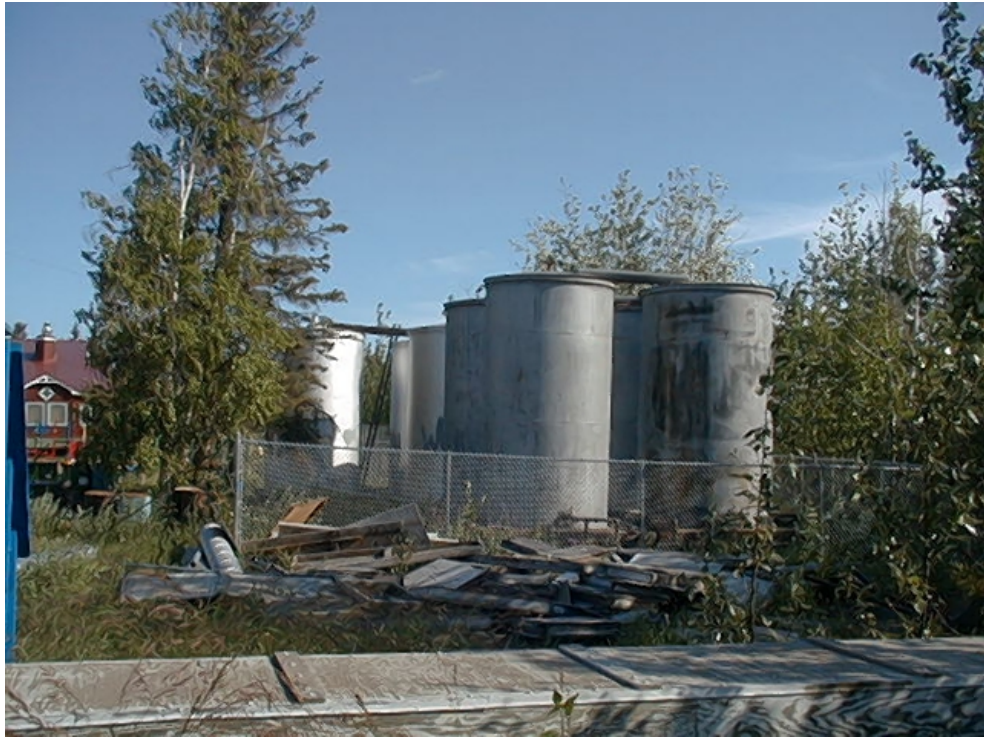
Photo # 02: South side of School Tank Farm.

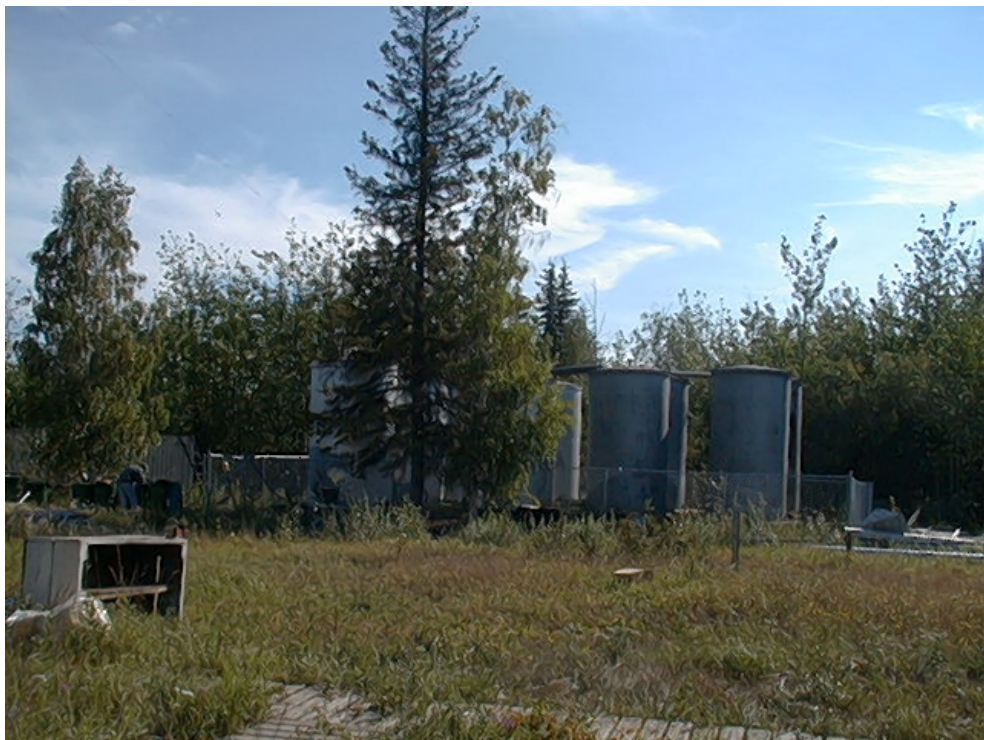
Photo # 01: West side of School Tank Farm.

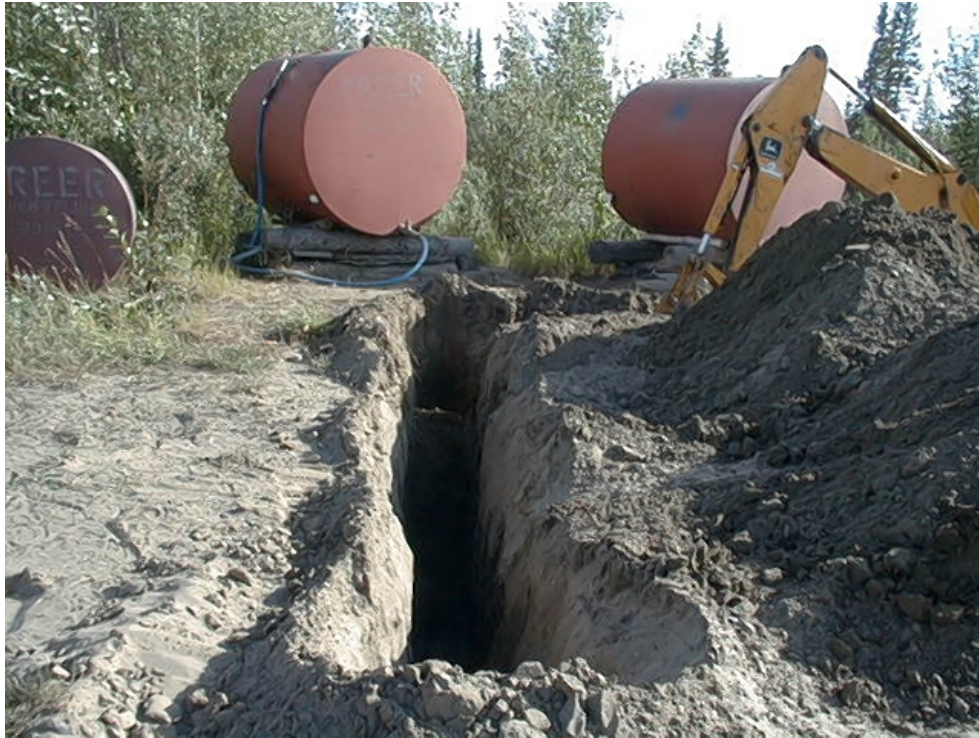
Photo # 68: Soil sample location at Airport Tank Farm.

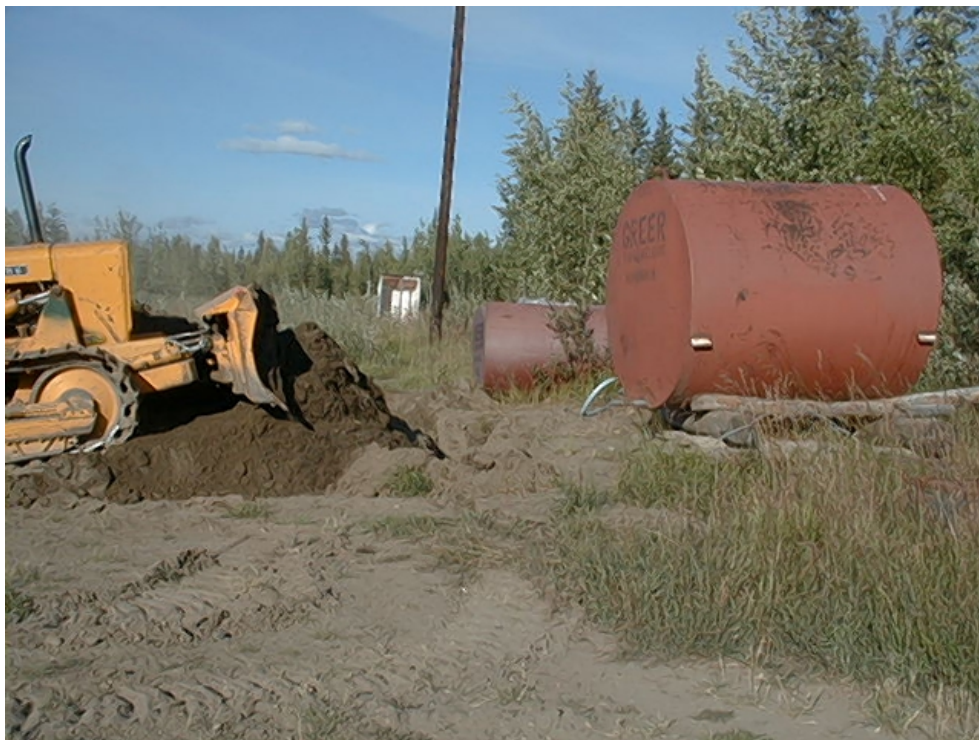
Photo #69 - BACKFILL AT NORTH SIDE OF AIRPORT TANKS.

Photo # 69: Soil sampling at Airport Tank Farm.

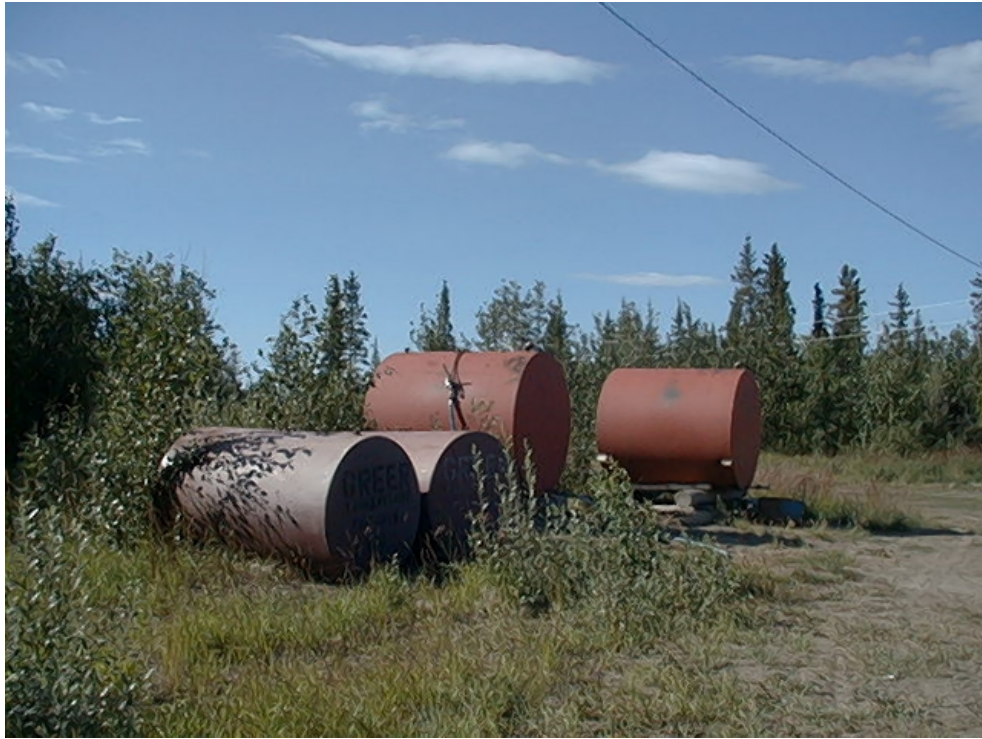
Photo # 12: Airport Storage Tanks.

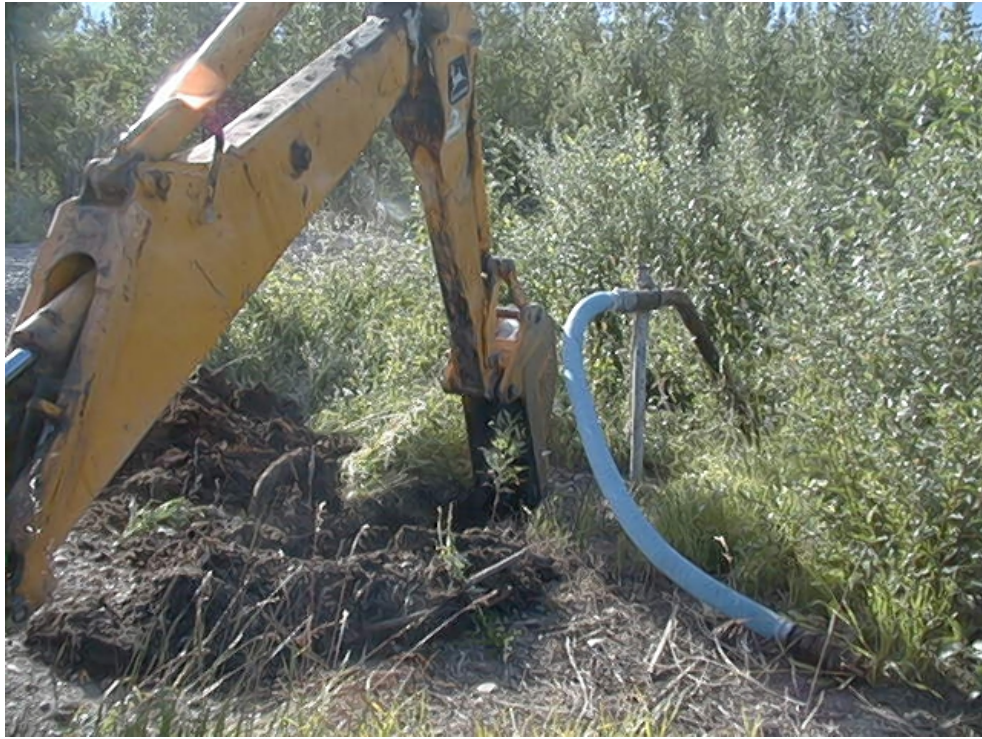
Photo # 70: Soil sample location at Airport Pipeline.

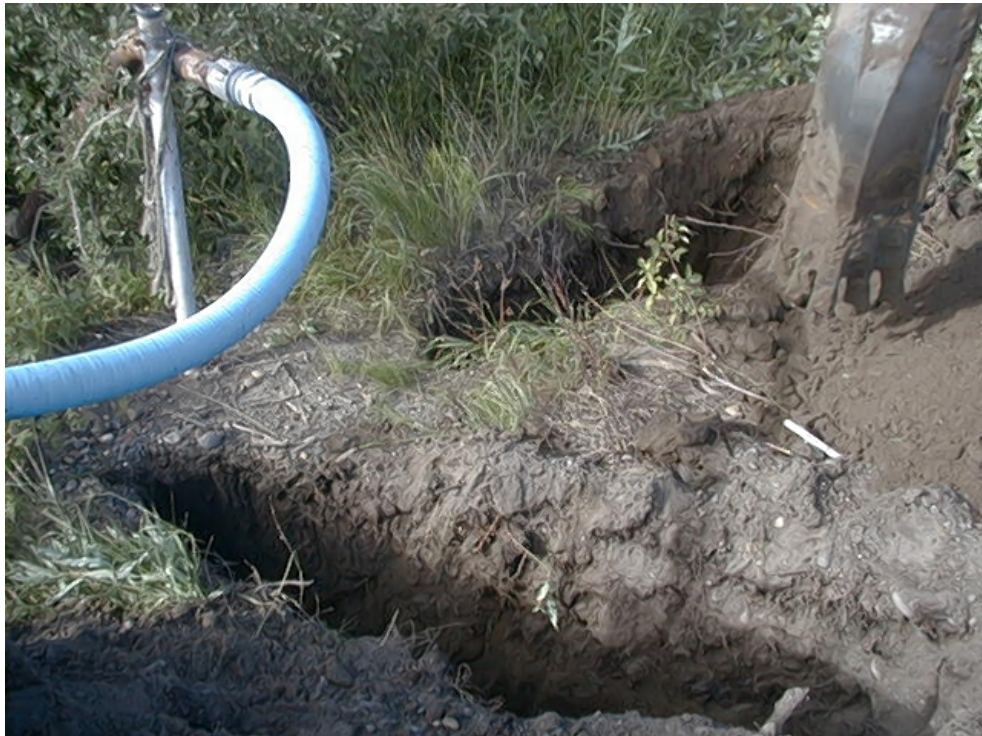
Photo # 73: Soil sample pit at Airport Pipeline.

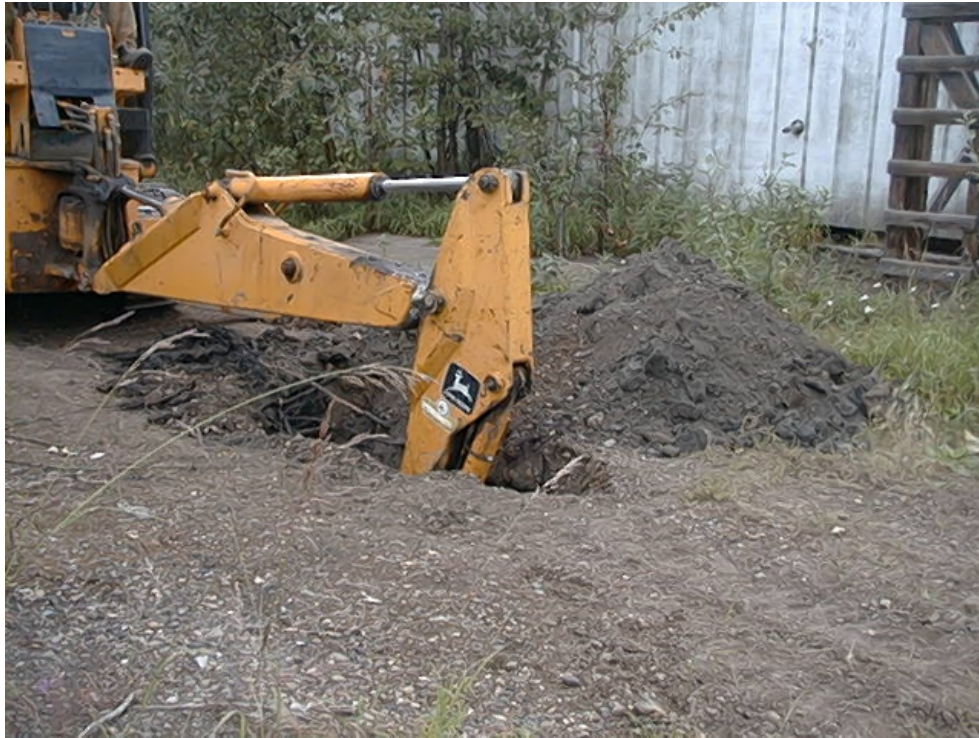
Photo # 111: Soil sample test pit next to Old Generator Building.

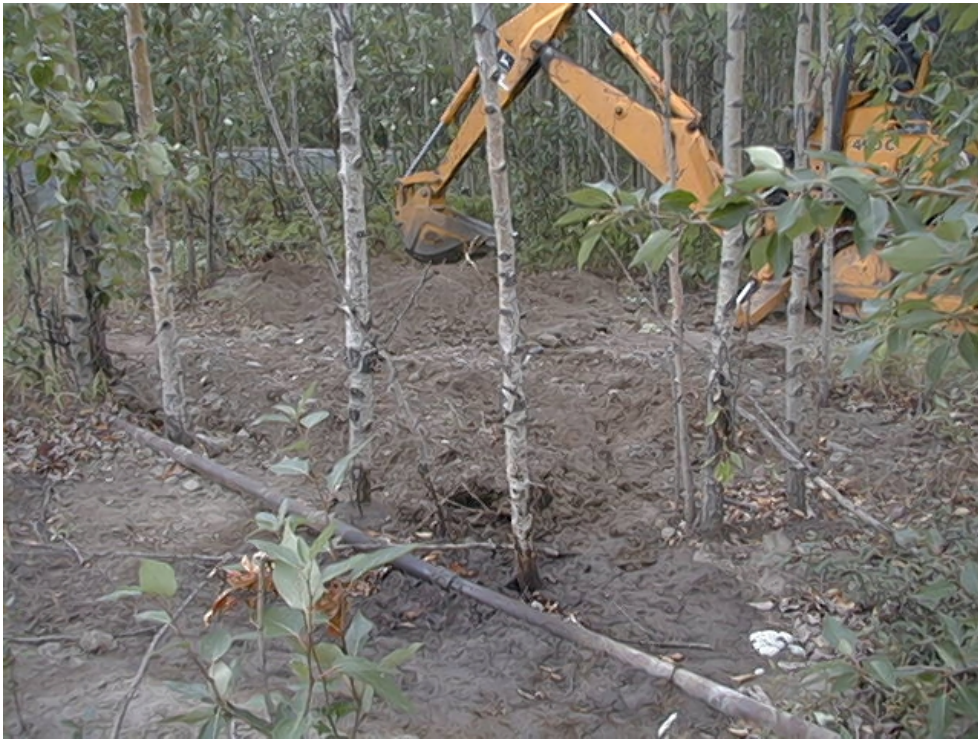
Photo # 107: Soil sample location at PLP3-1.

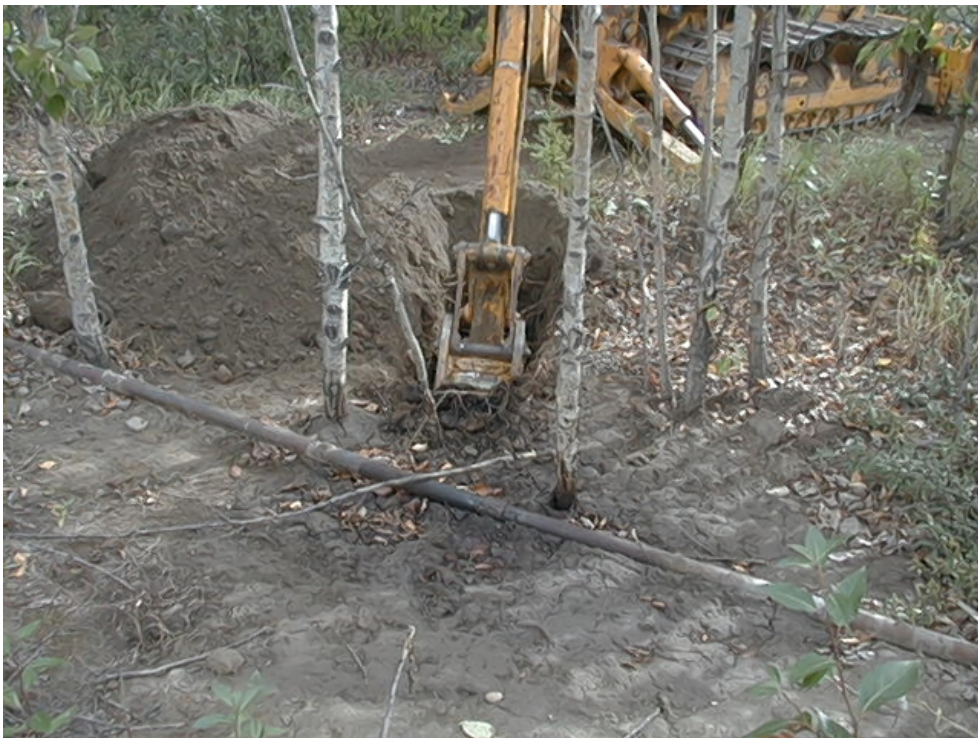
Photo # 104: Soil sample location at PLP1-1,1-2,1-3.

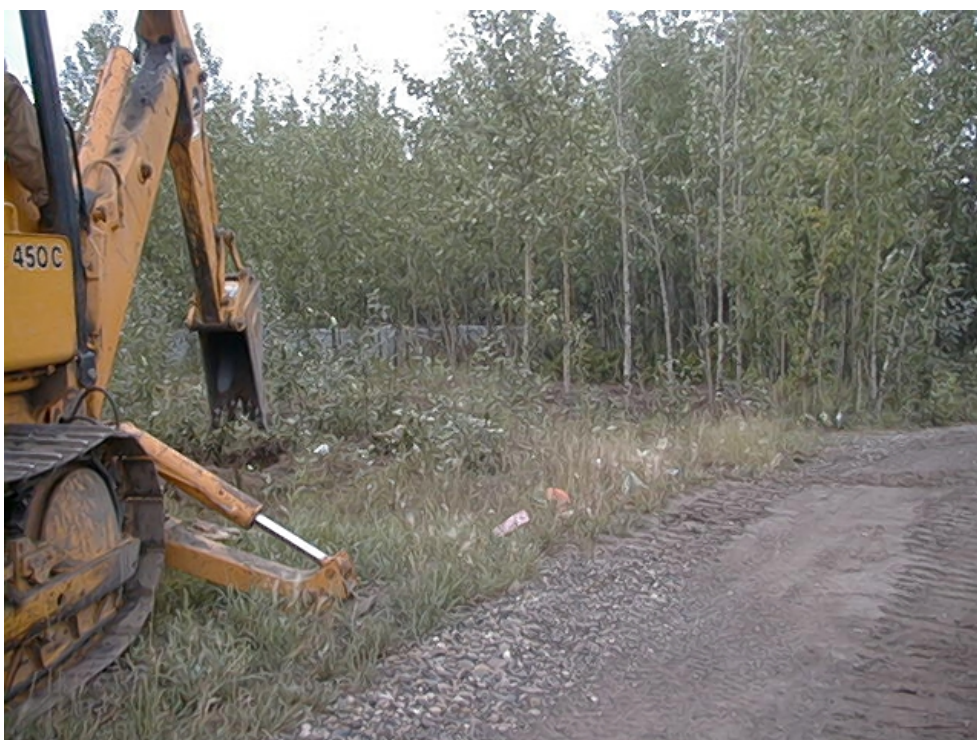
Photo # 109: Soil sample location at PLP5-1.
